**Whitetopping an Existing Asphalt
Pavement with Polyolefin
Fiber Enriched PCC**

Second Evaluation Report

Project IM-1-094(040)193

August 2001

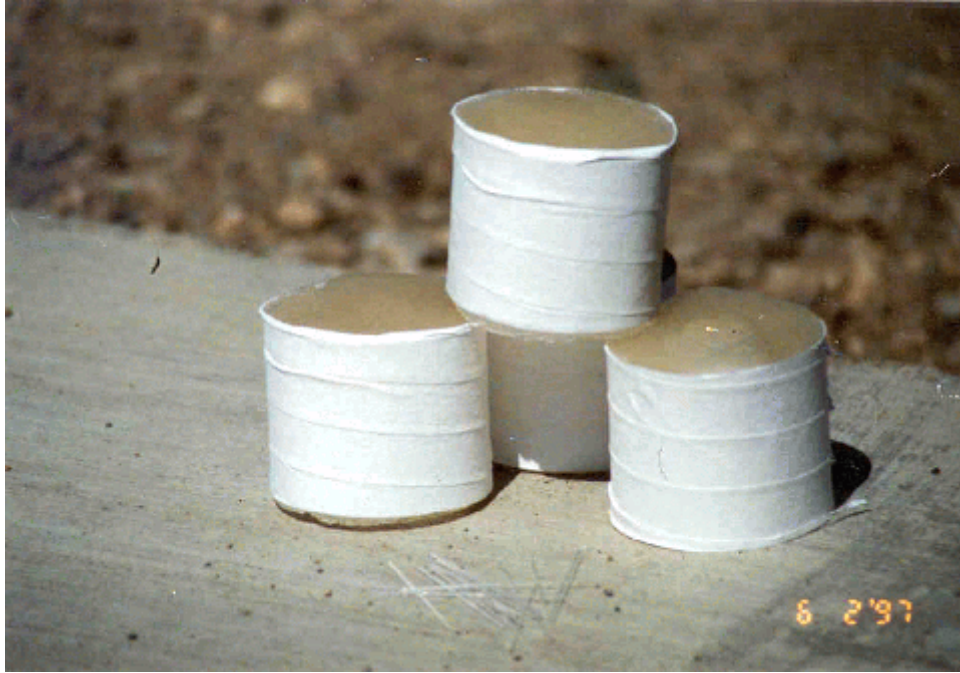
The 3M corporation has created a new fiber material which it calls the Polyolefin Fiber System. The Polyolefin Fiber System is comprised of 2" polyolefin macrofiber bundles as shown in photo 1 on the following page. 3M believes polyolefin fibers are unique in that, even with high volumes added, they are easily dispersed into the PCC mix and also offer non-corrosive properties.

Photo 1. View of the Polyolefin Fiber System

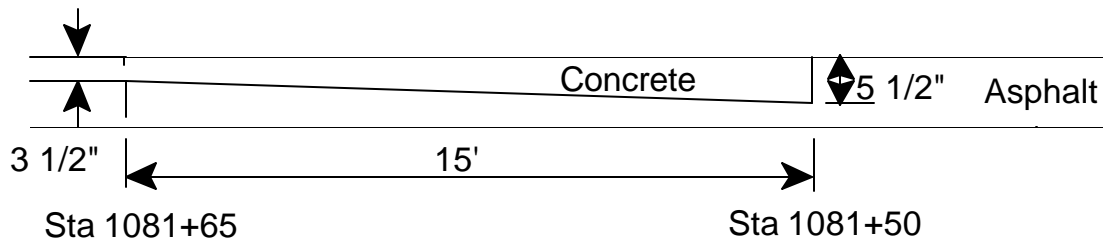
Figure 1

The proposed length of the whitetopping test section will be 255' which includes an additional 15' wedged shaped section at the north end of the test section. This thickened edge section is designed to carry additional stresses transferred between the interface of the PCC and bituminous pavement lying adjacent and to the north of the test section. Experimental sections done in other states have experienced distresses in the first slab adjacent to the asphalt pavement. This transition section, as shown in Figure 1, will increase to a thickness of approximately 5-1/2" at the interface.

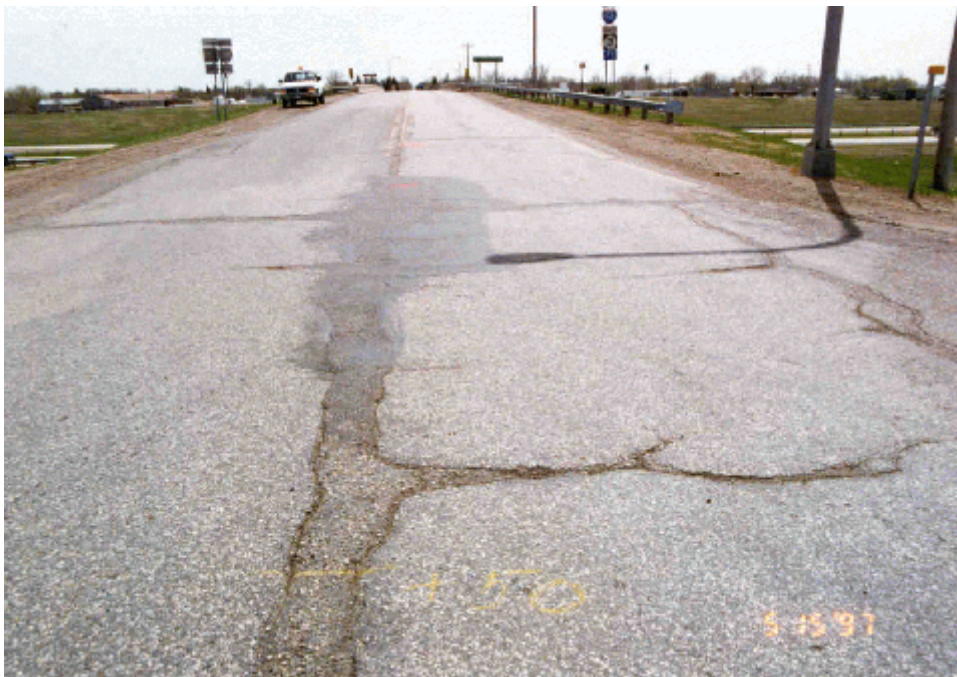
Photo 2. An overview of the existing roadway, prior to milling, where the whitetopping section is now located (looking south).

Photo 2 depicts an overview of the existing roadway before construction began. A survey was conducted during this visit to determine how many distresses were present, including any longitudinal and transverse cracking. The stationing of each distress was also recorded. This information may be useful in determining if the PCC overlay will control reflective cracking.

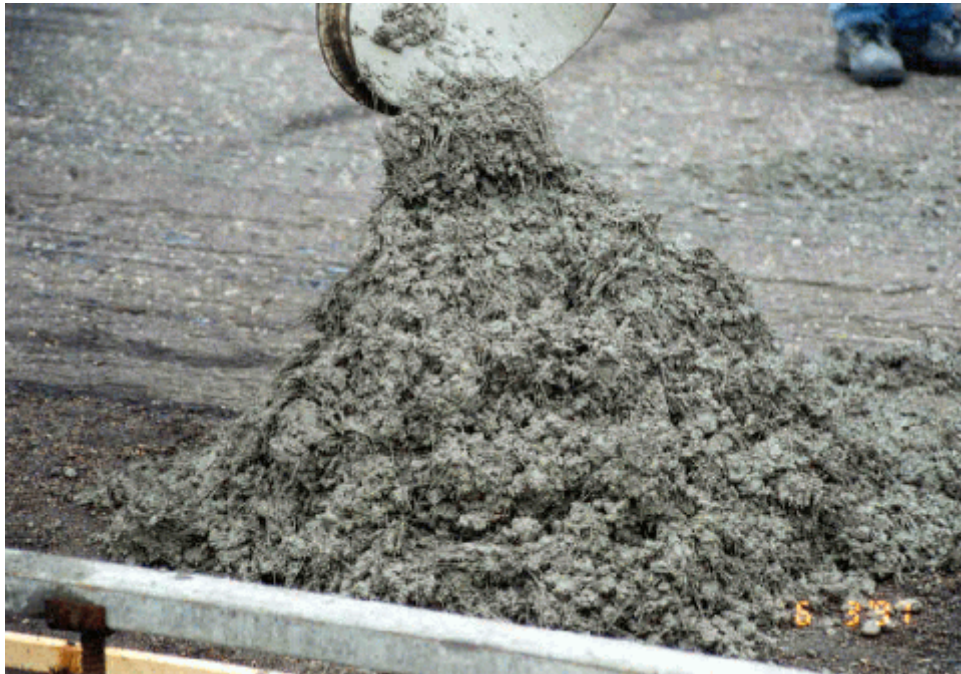
Photo 3. A view of the polyolefin fiber PCC as it is discharged from the mixing truck.

Photo 3 shows the consistency of the fiber PCC as it is discharged from the mixing truck.

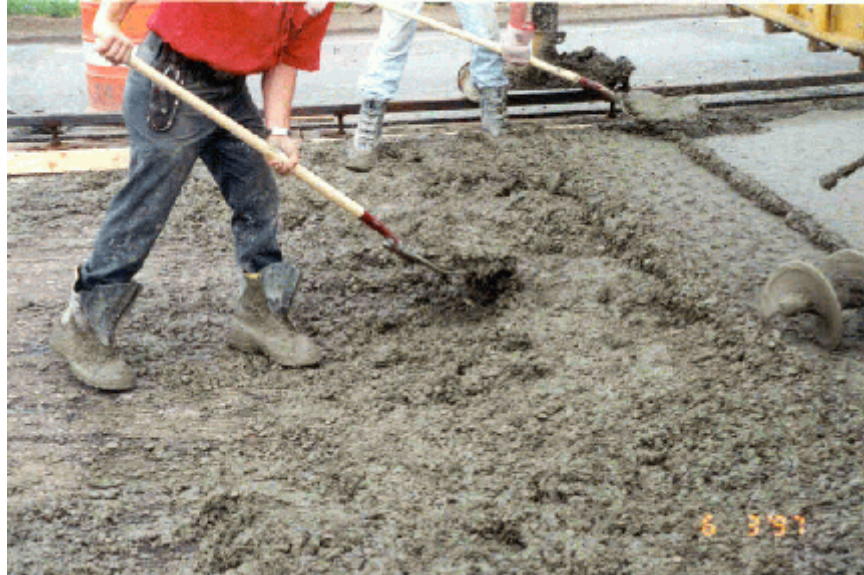
Photo 4. Shows the use of pitchforks to spread the fiber reinforced concrete.

Photo 4 the shows the contractor's use of pitchforks to move and place the fiber rich PCC because of the decreased workability of the material. Photo 5 depicts a view of the joints being cut by the Soft-Cut procedure. This procedure is a slightly different procedure than that of the traditional saw cutting.

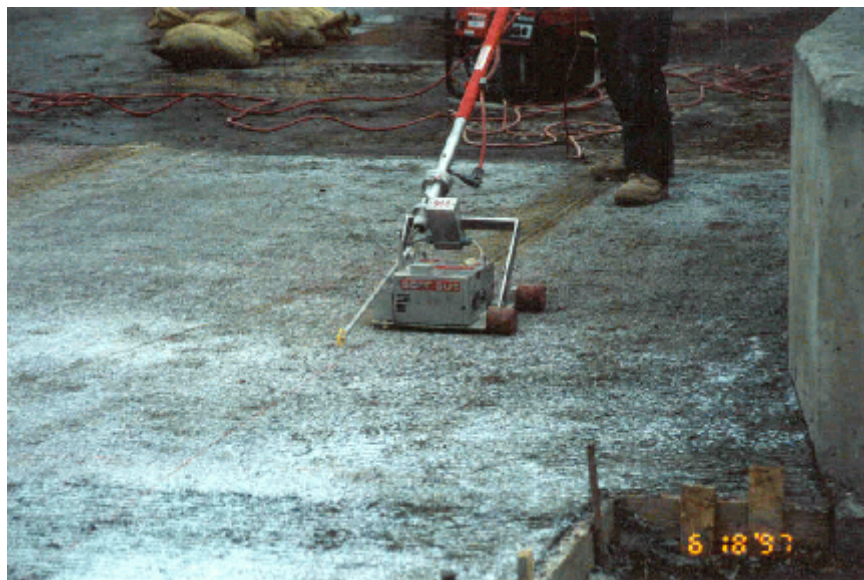
Photo 5. A view of the joints being sawed by the soft-cut procedure

One advantage of the soft cut is the ability to start cutting several hours sooner. Time is a critical factor in this type of sawing operation.

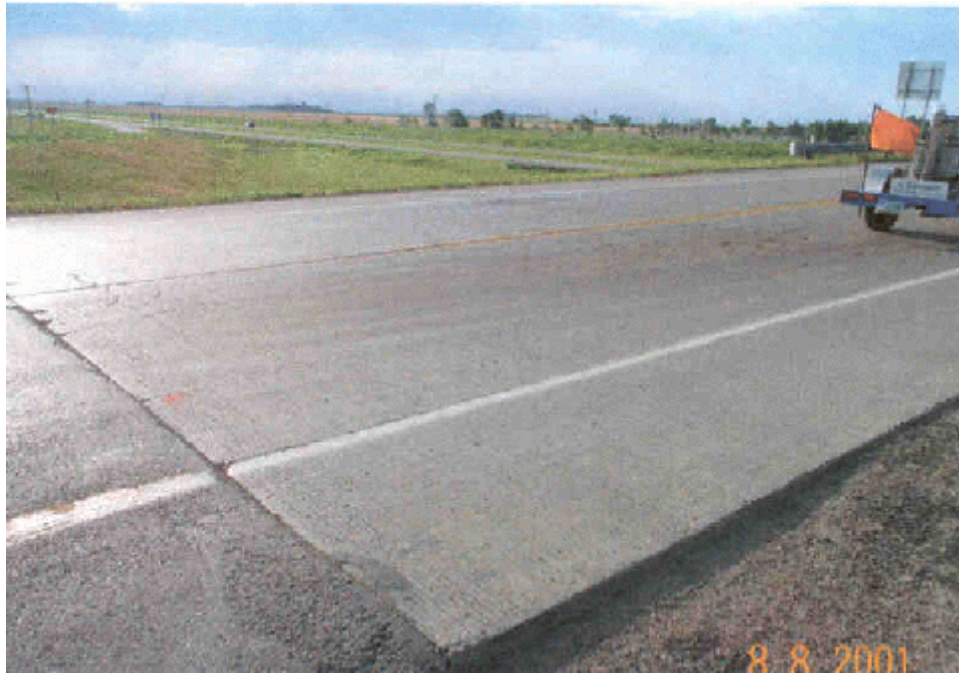
Photo 6. View of North side of project

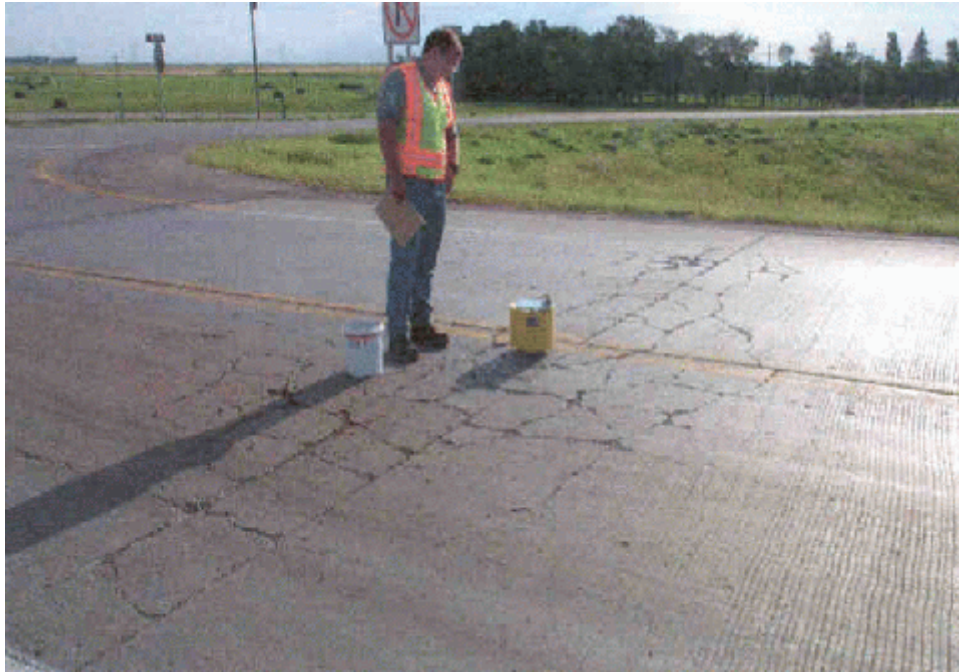
Cracks similar to map cracking have broken the PCC into several 1 to 2 square foot blocks. Photo 7 shows an example of this type of cracking. These breakups were experiencing severe spalling and some PCC had become dislodged despite the efforts of the polyolefin fibers to hold it in place. It appeared that several weathering cycles and heavy traffic had broken the bonds between the fibers and PCC at this joint.

Photo 7. Map cracking occurring at the first joint on the north side of the project.

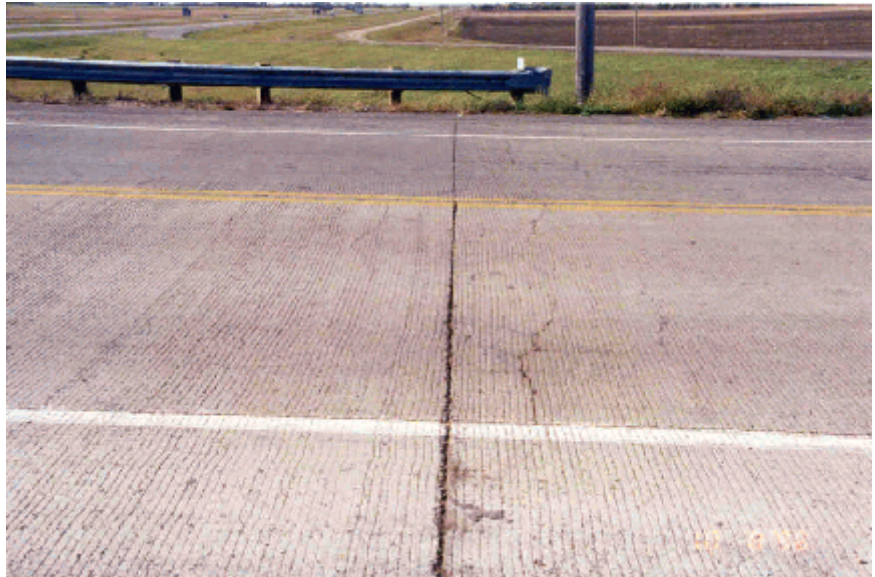
Since the last evaluation in 1998 the distresses have moved progressively outward and increased in severity. Photo 8 shows a picture of the first joint in the 25' panels in 1998.

Photo 8. Shows the 1st joint on the north side of the project in 1998.

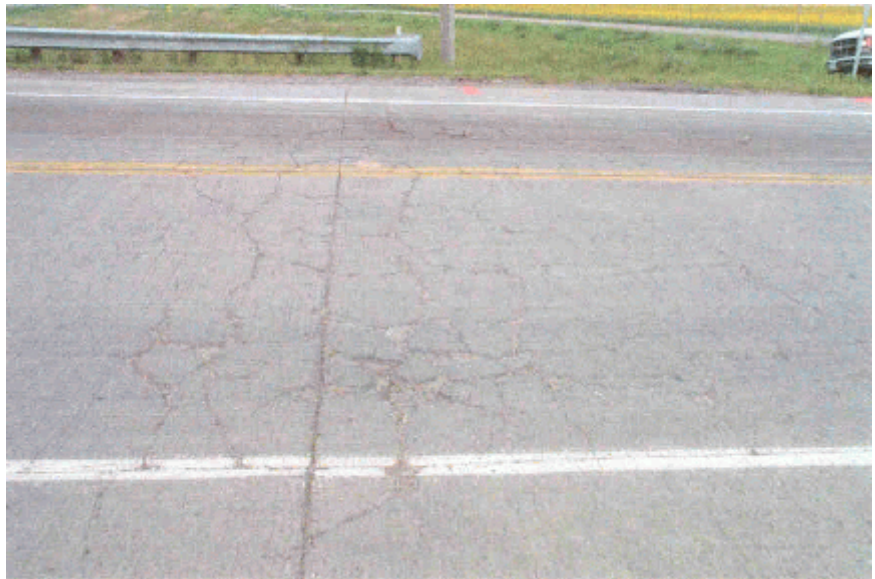
Photo 9 shows that same joint in 2001. This joint located between the first two 25' panels seemed to be performing very poorly.

Photo 9. Shows the same joint as in photo 8, but in 2001.

The cracks in the polyolefin fiber concrete mix have increased drastically in severity since the last review. It appears some maintenance may be required in the three 25' sections to prevent any further breakups and improve the overall ride. It was apparent to the review team that in general, as the joint spacing increases, the performance of the concrete decreases. Joint spaces of less than 15' were performing at a satisfactory level. However, panels with joint spacing of greater than 15' showed several signs of cracking, faulting, and spalling.

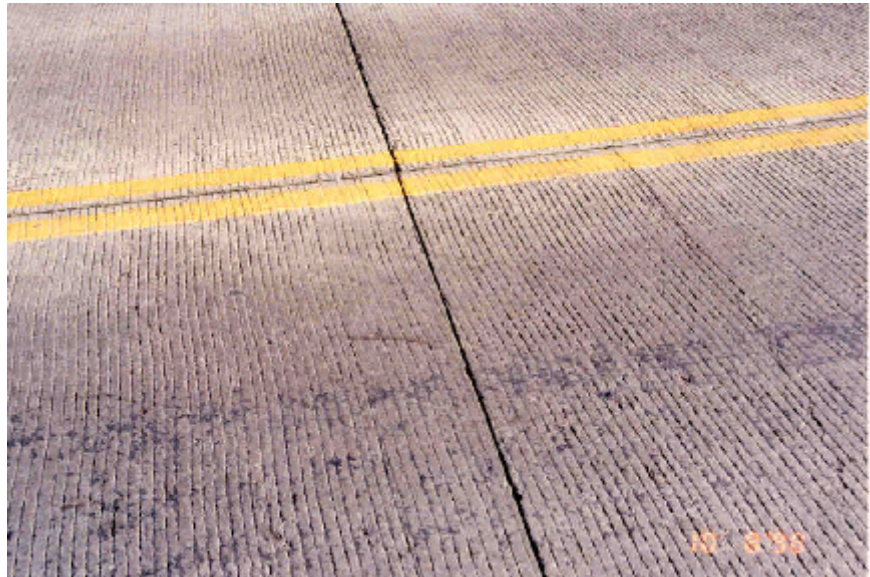
Photos 10 and 11 show this joint in 1998 and 2001 respectively.

Photo 10. Shows the 2nd joint on the north side of the project in 1998.

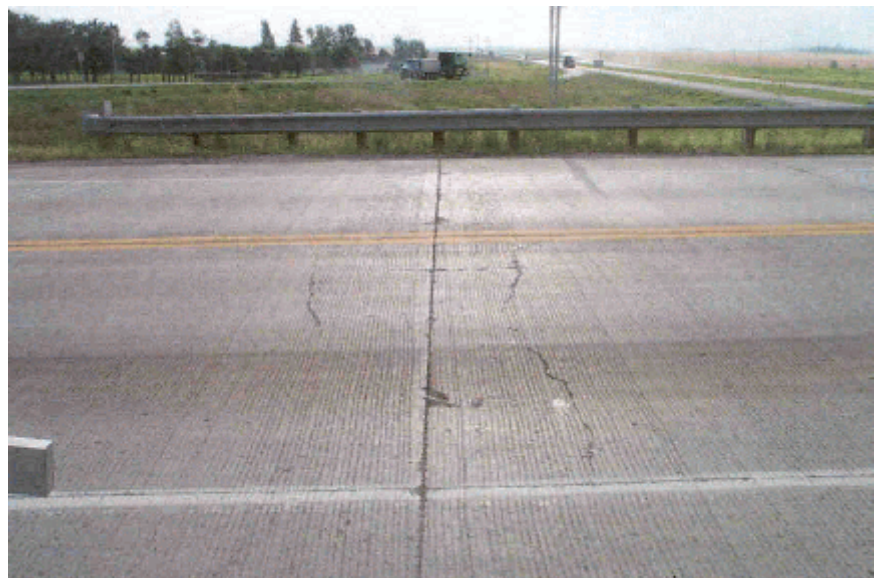
The second joint from the North side of the project also was experiencing some transverse and secondary cracking along the joint. Like the first joint, our most recent field review showed that most of the cracks have increased in their level of severity. The number of cracks had also increased, and spalling along cracks and joints has occurred.

Photo 11. A view of the second joint in 2001.

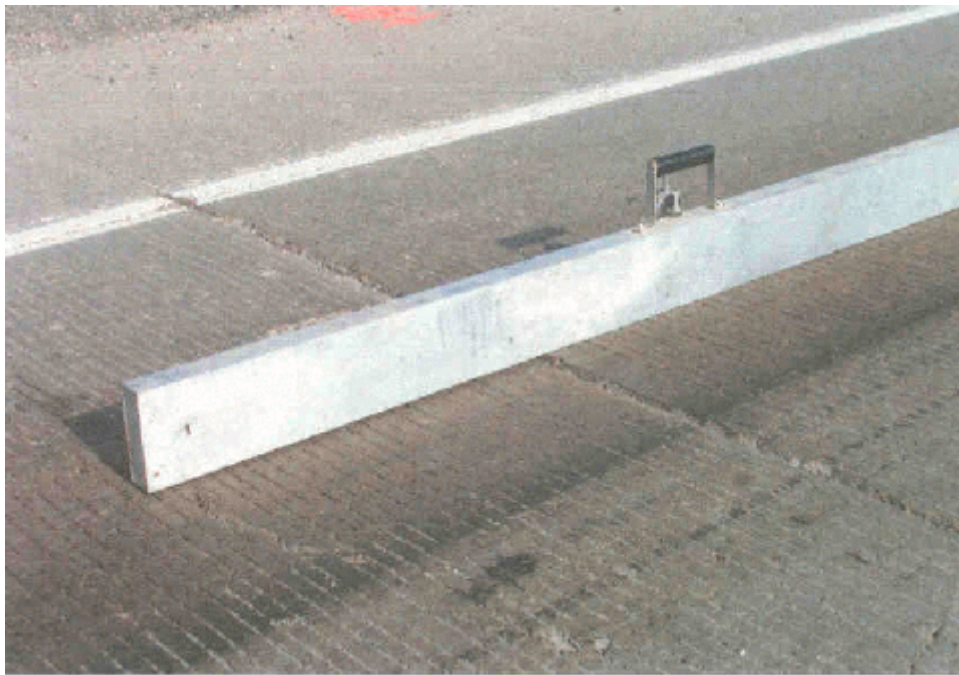
Several other joints in the SB lane have also experienced faulting ranging from 1/8" to 1/2". The joints in the NB lane did not show any signs of faulting. Photo number 12 shows faulting that has occurred at one of the SB lane joints.

Photo 12. Faulting that has occurred in the SB lane

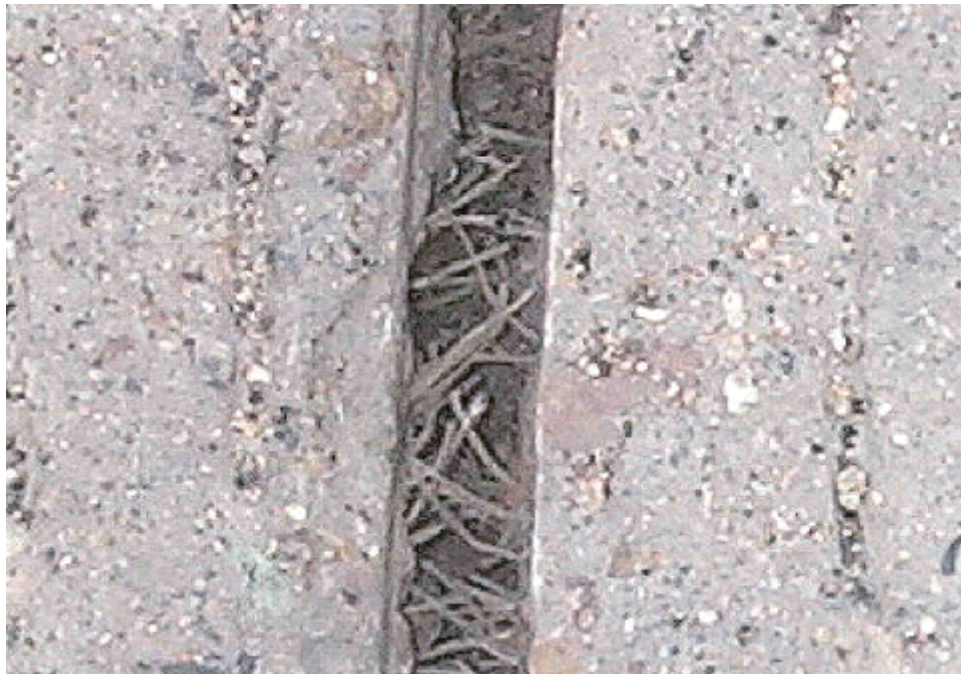
The field team also inspected the fibers effect on the widening of the joints. It appears that most of the fibers were broken and no longer tied to the adjoining panels. Some joint spaces, like the one shown in photo 13 have widened to over 3/4".

Photo 13. Fibers have broken after joint widening has occurred

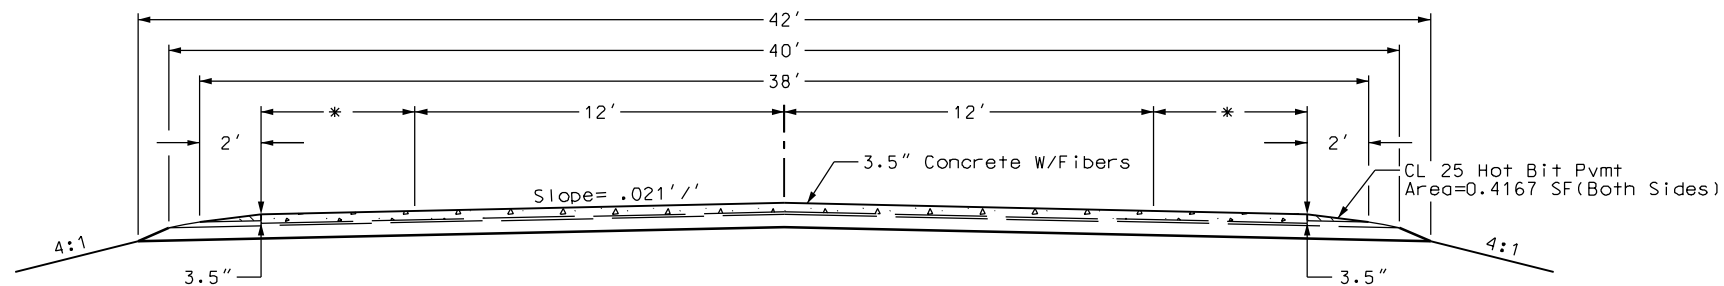
Whitetop Section
Sta 1081+65 to Sta 1084+05.9

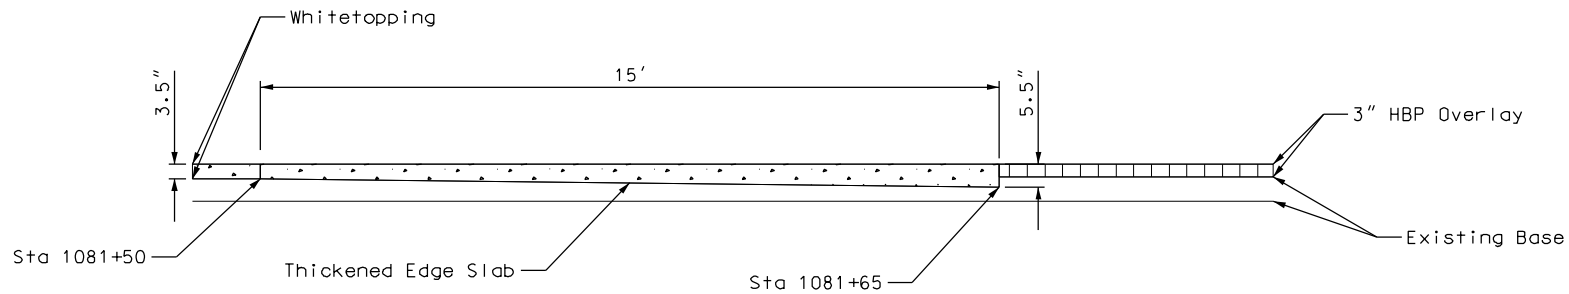
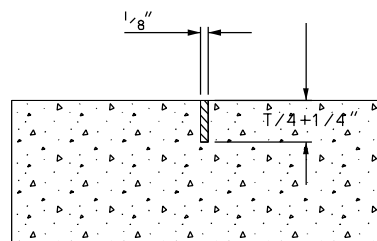
TRANSVERSE AND LONGITUDINAL JOINT SAWING DETAIL
(NOT TO BE SEALED)

WHITETOPPING JOINT AND
THICKENED EDGE LAYOUTS

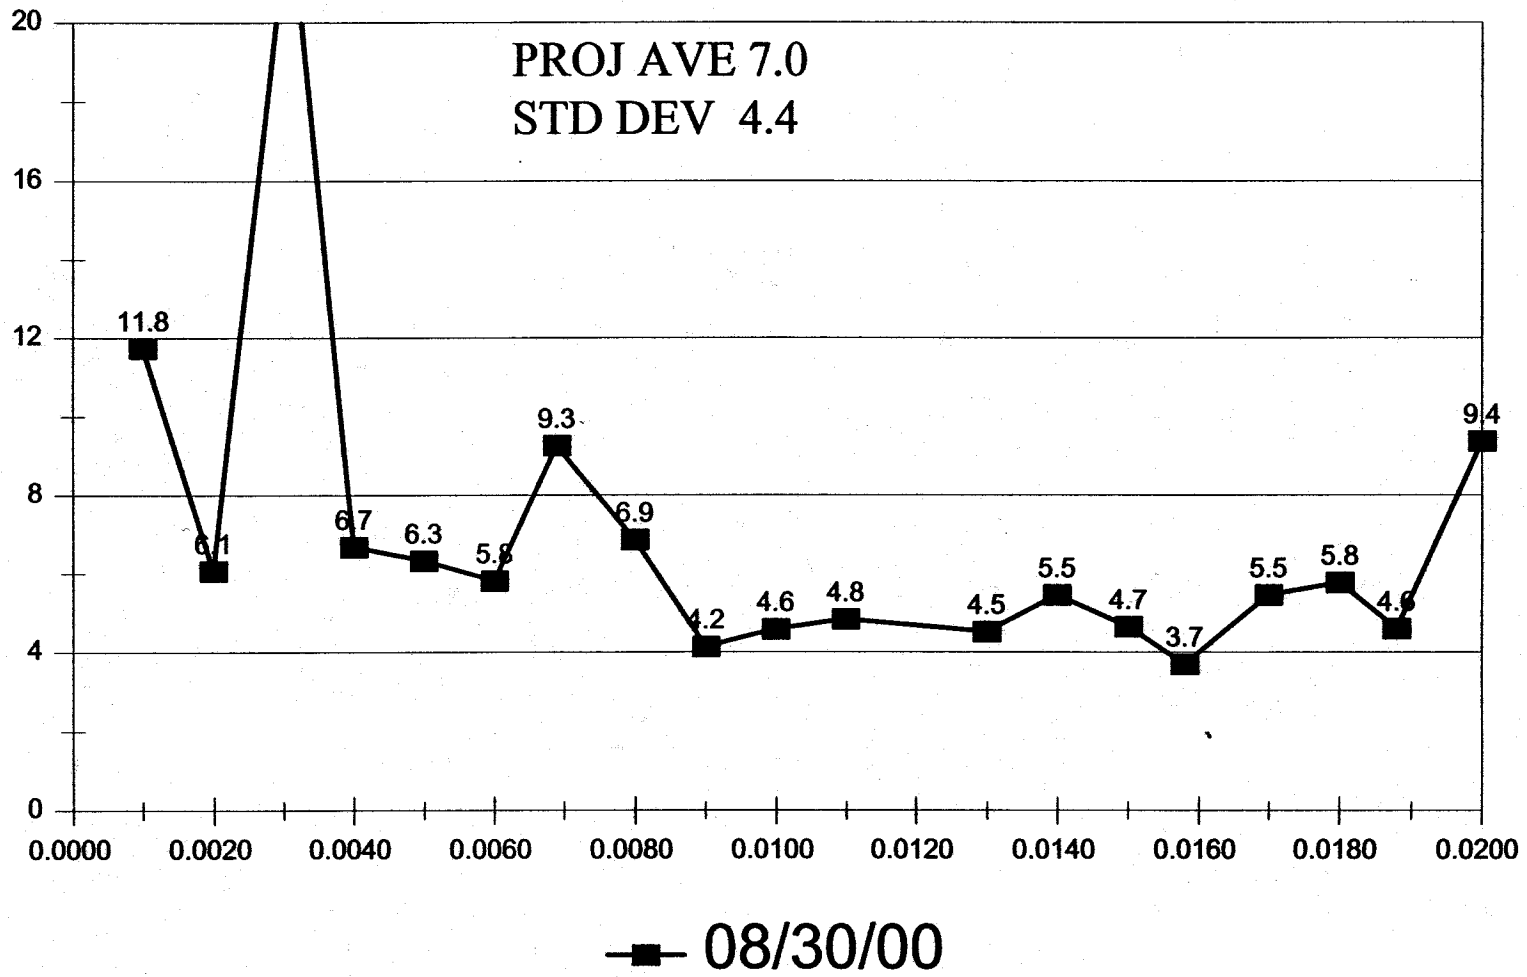
SUBGRADE MODULI - EAST LANE

The FWD also appeared to show a decrease of nearly 1400 psi in the soil modulus beneath the entire test section from 2000 to 2001. The average modulus changed from

7000 psi in 2000 to 5600 psi in 2001. This weakening subgrade seems to be having some effect on the performance of the PCC overlay. The SB lane had a particularly low soil modulus in the

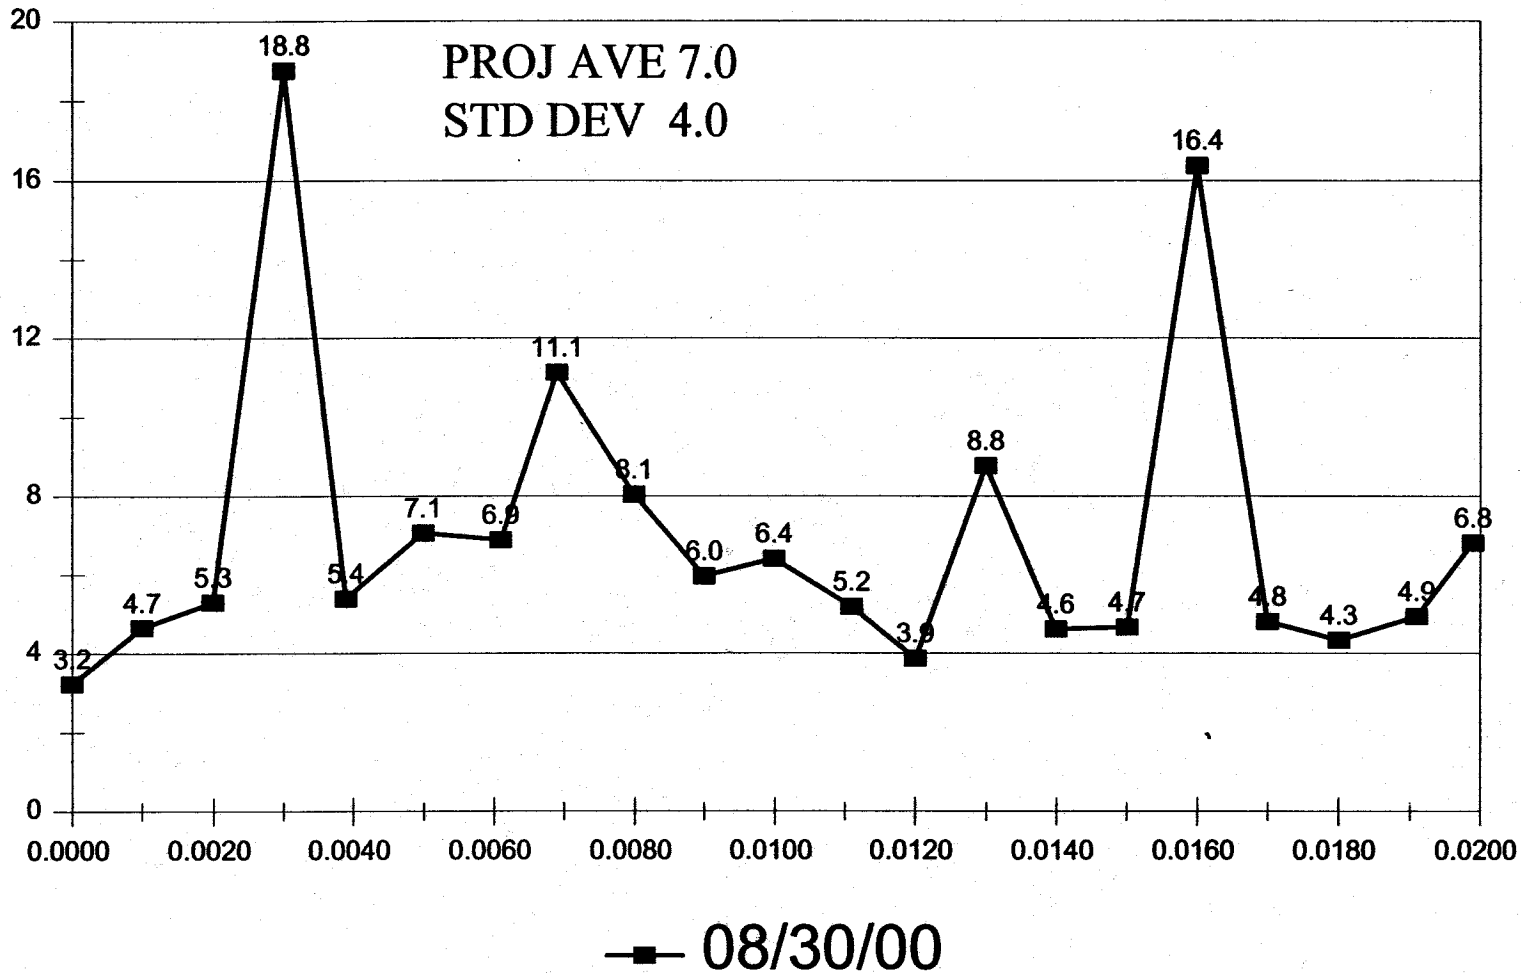
SUBGRADE MODULI - WEST LANE

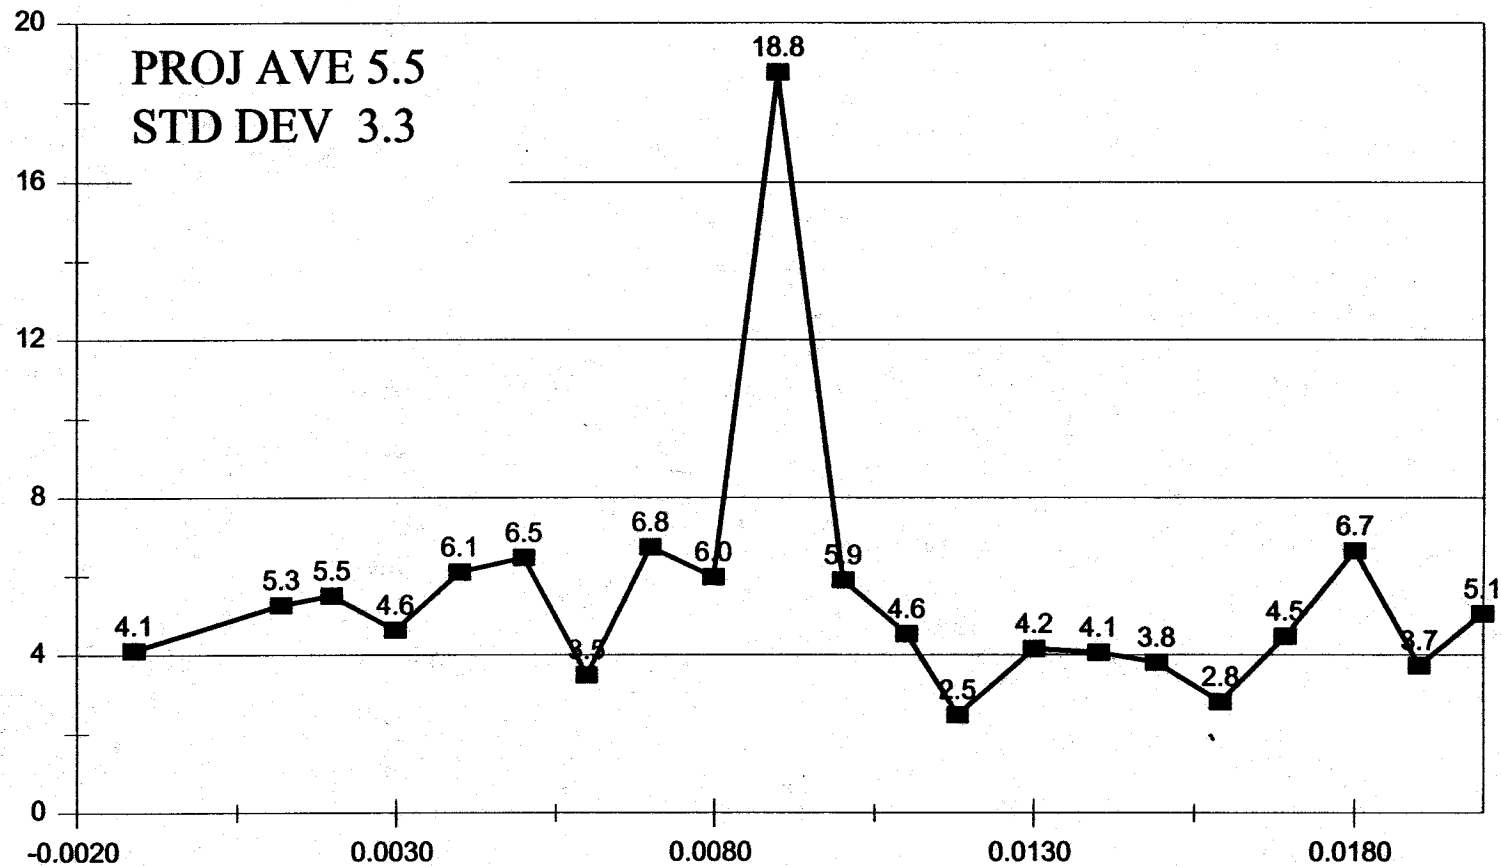
SUBGRADE MODULI - EAST LANE

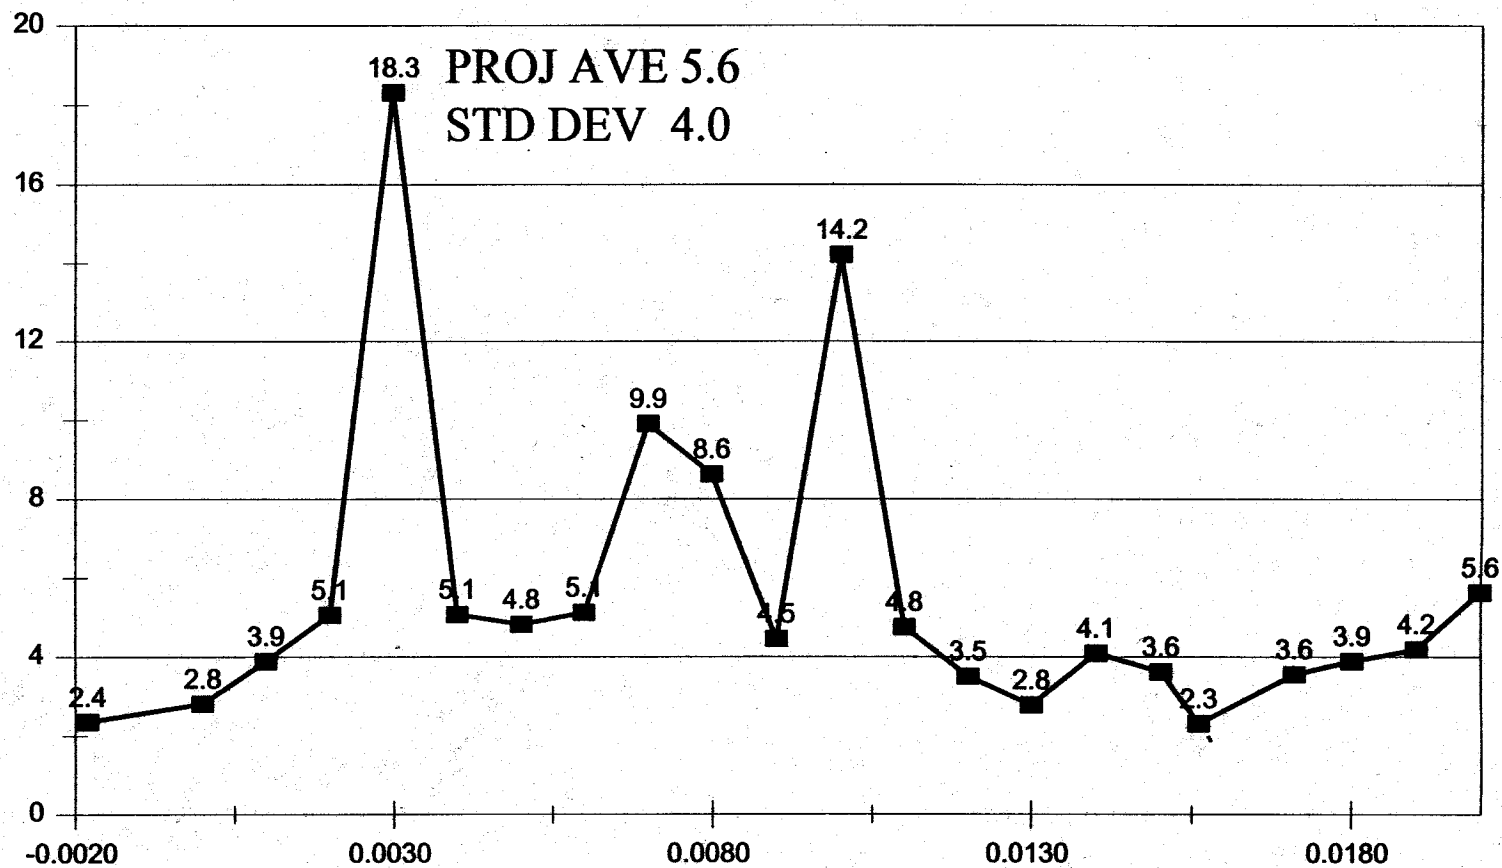
SUBGRADE MODULI - WEST LANE
